Contract #: 04-0120F4Cty: SF/ALA Rte: 80 PM: 13.2/13.9File #: 13.28**WELDING INSPECTION REPORT****Resident Engineer:**Pursell, Gary**Address:** 333 Burma Road**City:** Oakland, CA 94607**Report No:** WIR-013878**Date Inspected:** 05-May-2010**Project Name:** SAS Superstructure**OSM Arrival Time:** 1000**Prime Contractor:** American Bridge/Fluor Enterprises, a JV**OSM Departure Time:** 1830**Contractor:** Oregon Iron Works Clackamas, Or.**Location:** Clackamas, OR

**Hinge-K Pipe Beam Assembly 101A-4:**

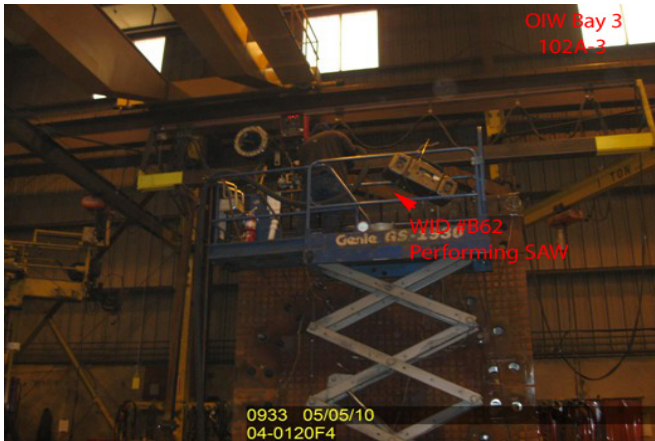
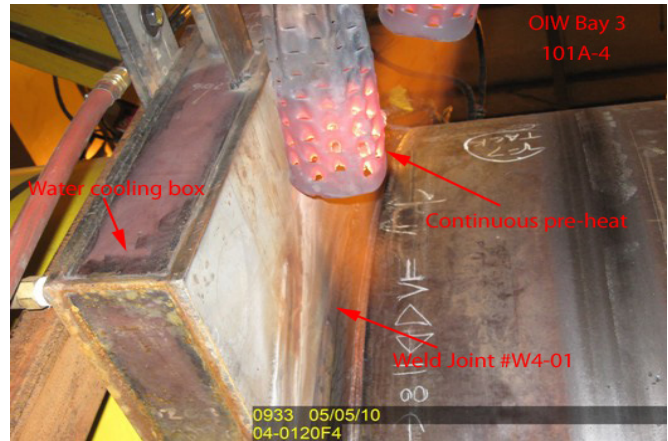
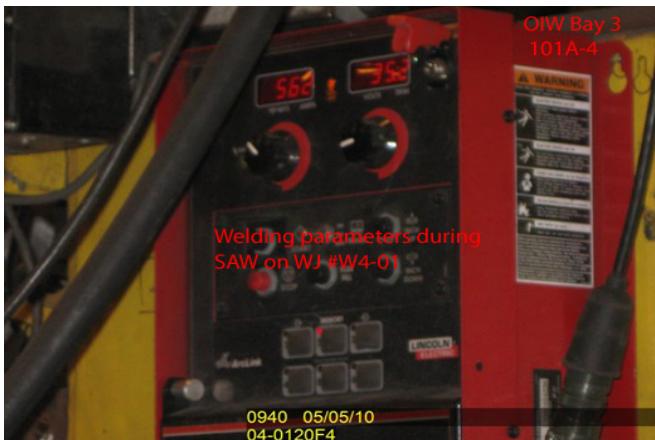
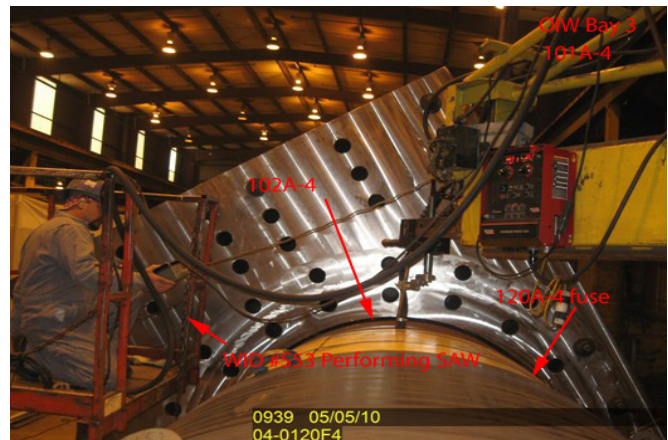
The QA Inspector later observed WID #S53 (Jerry Shephard) performing the SAW on the above mentioned weld joint in the flat (1G) position. The QA Inspector observed that the pre-heat was being applied to the joint with the previously set-up two stationary rosebud torches, which were used during the SAW on the interior portion of the weld joint. The QA Inspector randomly verified the temperature, near the source of SAW filler metal which was being deposited and recorded a minimum temperature of 350 degrees Fahrenheit. The QA Inspector randomly observed that the in-process welding parameters were 562 amps and 35.2 volts, which appeared to be in compliance with the applicable WPS 4016. The QA Inspector observed that QC Inspector Salazar was present and Mr. Salazar explained that he was intermittently monitoring the welding parameters and pre-heat during the SAW, at approximately 30 minute intervals. The QA Inspector noted that the SAW being performed, appeared to be in compliance with AWS D1.5 and the applicable WPS. QC Inspector Salazar explained that the SAW will continue throughout the entire shift and will continue on swing.

The QA Inspector was present on this swing shift and observed WID #B10 (Liem Bui) continuing to perform the SAW, on the above mentioned weld joint. The QA Inspector observed that OIW QC Inspector Gary Mundt was present on this shift. QC Inspector Mundt explained that he was intermittently monitoring and recording the welding parameters, during the SAW. QC Inspector Mundt explained that he had recorded average, in-process parameters of 600 amps, 33 volts and a travel speed of 22 inches per minute. QC Inspector Mundt explained that he had recorded pre-heat temperatures of approximately 350 degrees Fahrenheit. The QA Inspector observed that the stationary rosebud torches, which OIW is using to pre-heat the joint, have been consistently applying the pre-heat between shifts and the QA Inspector randomly checked the pre-heat. The pre-heat temperature was approximately 350 degrees Fahrenheit. QC Inspector Mundt explained that WID #B10 will continue the SAW throughout the shift and will probably resume on Graveyard shift. The QA Inspector noted that per the contract requirements, that OIW will have to grind the outside cap flush with the base material, after the SAW is complete. See attached pictures below.
